# Treated Wood in Aquatic Environments

A Specification and Environmental  
Guide to Selecting, Installing and  
Managing Wood Preservation Systems  
in Aquatic and Wetland Environments

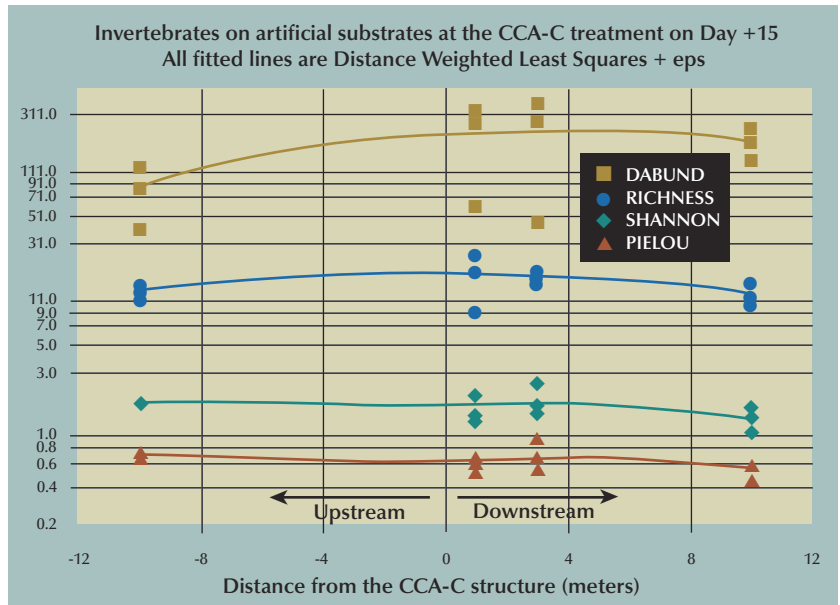
Figure 2 describes the response of invertebrates most exposed to the peak concentrations of dissolved copper observed two weeks after construction of the CCA-C viewing platform. Copper declined dramatically in all subsequent samples confirming that this first two-week period represented the worst case for this part of the insect community.

As many or more invertebrates were collected from the artificial substrates located immediately next to the treated wood (0 to 4 meters distance on chart) as were observed at the upstream control (-10 meters distance on chart). All of these indices (which measure the numbers and kinds of invertebrates and how well integrated they are in the community) showed no significant changes caused by the structure.

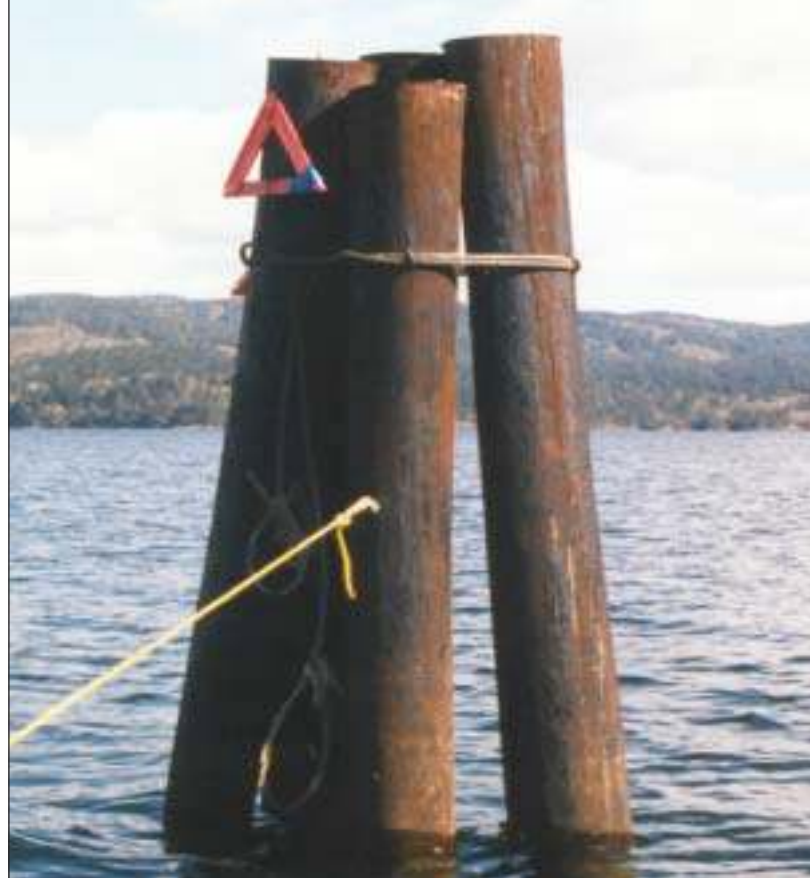
*New creosote-treated dolphin used to evaluate creosote in Sooke.*

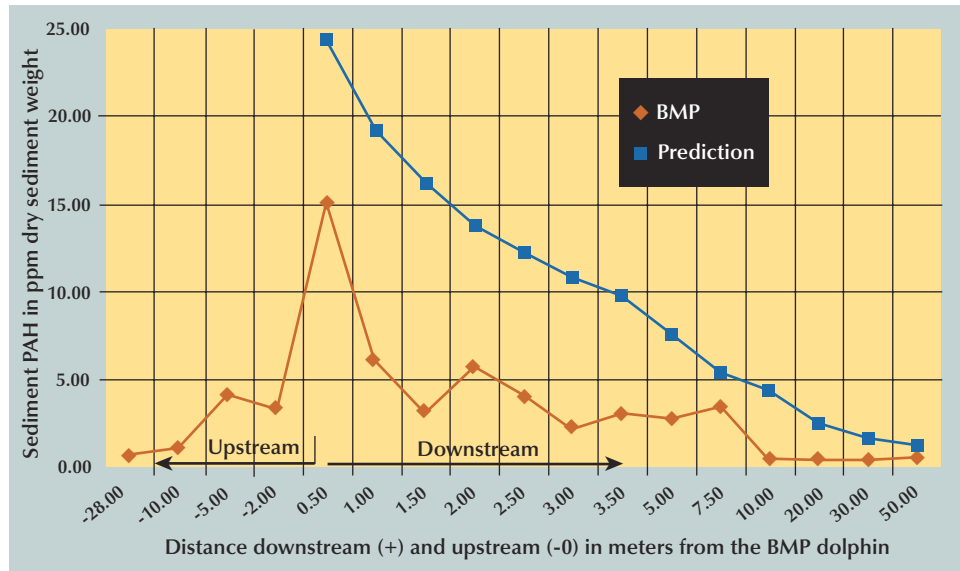
- Creosote did migrate from the piling and accumulate in sediments downcurrent from the piling. As shown in Figure 4 below, the actual accumulation of PAH in sediments (red line) was less than that predicted in the model (blue line). These sediment concentrations also peaked earlier and declined faster than predicted. These models have been field-verified repeatedly over the last six years. In every case, they have proven conservative from the environment's point of view – that is, predictions of PAH accumulation were higher than what was actually observed.

As previously noted, concentrations of PAH in the sediments peaked earlier and declined more quickly than predicted by the models. The fact that there were lower-than-expected levels of PAH is an important environmental observation. Perhaps more important was the fact that the piling provided habitat for an astounding array of aquatic life with no significant or lasting adverse impact from the creosote treatment.

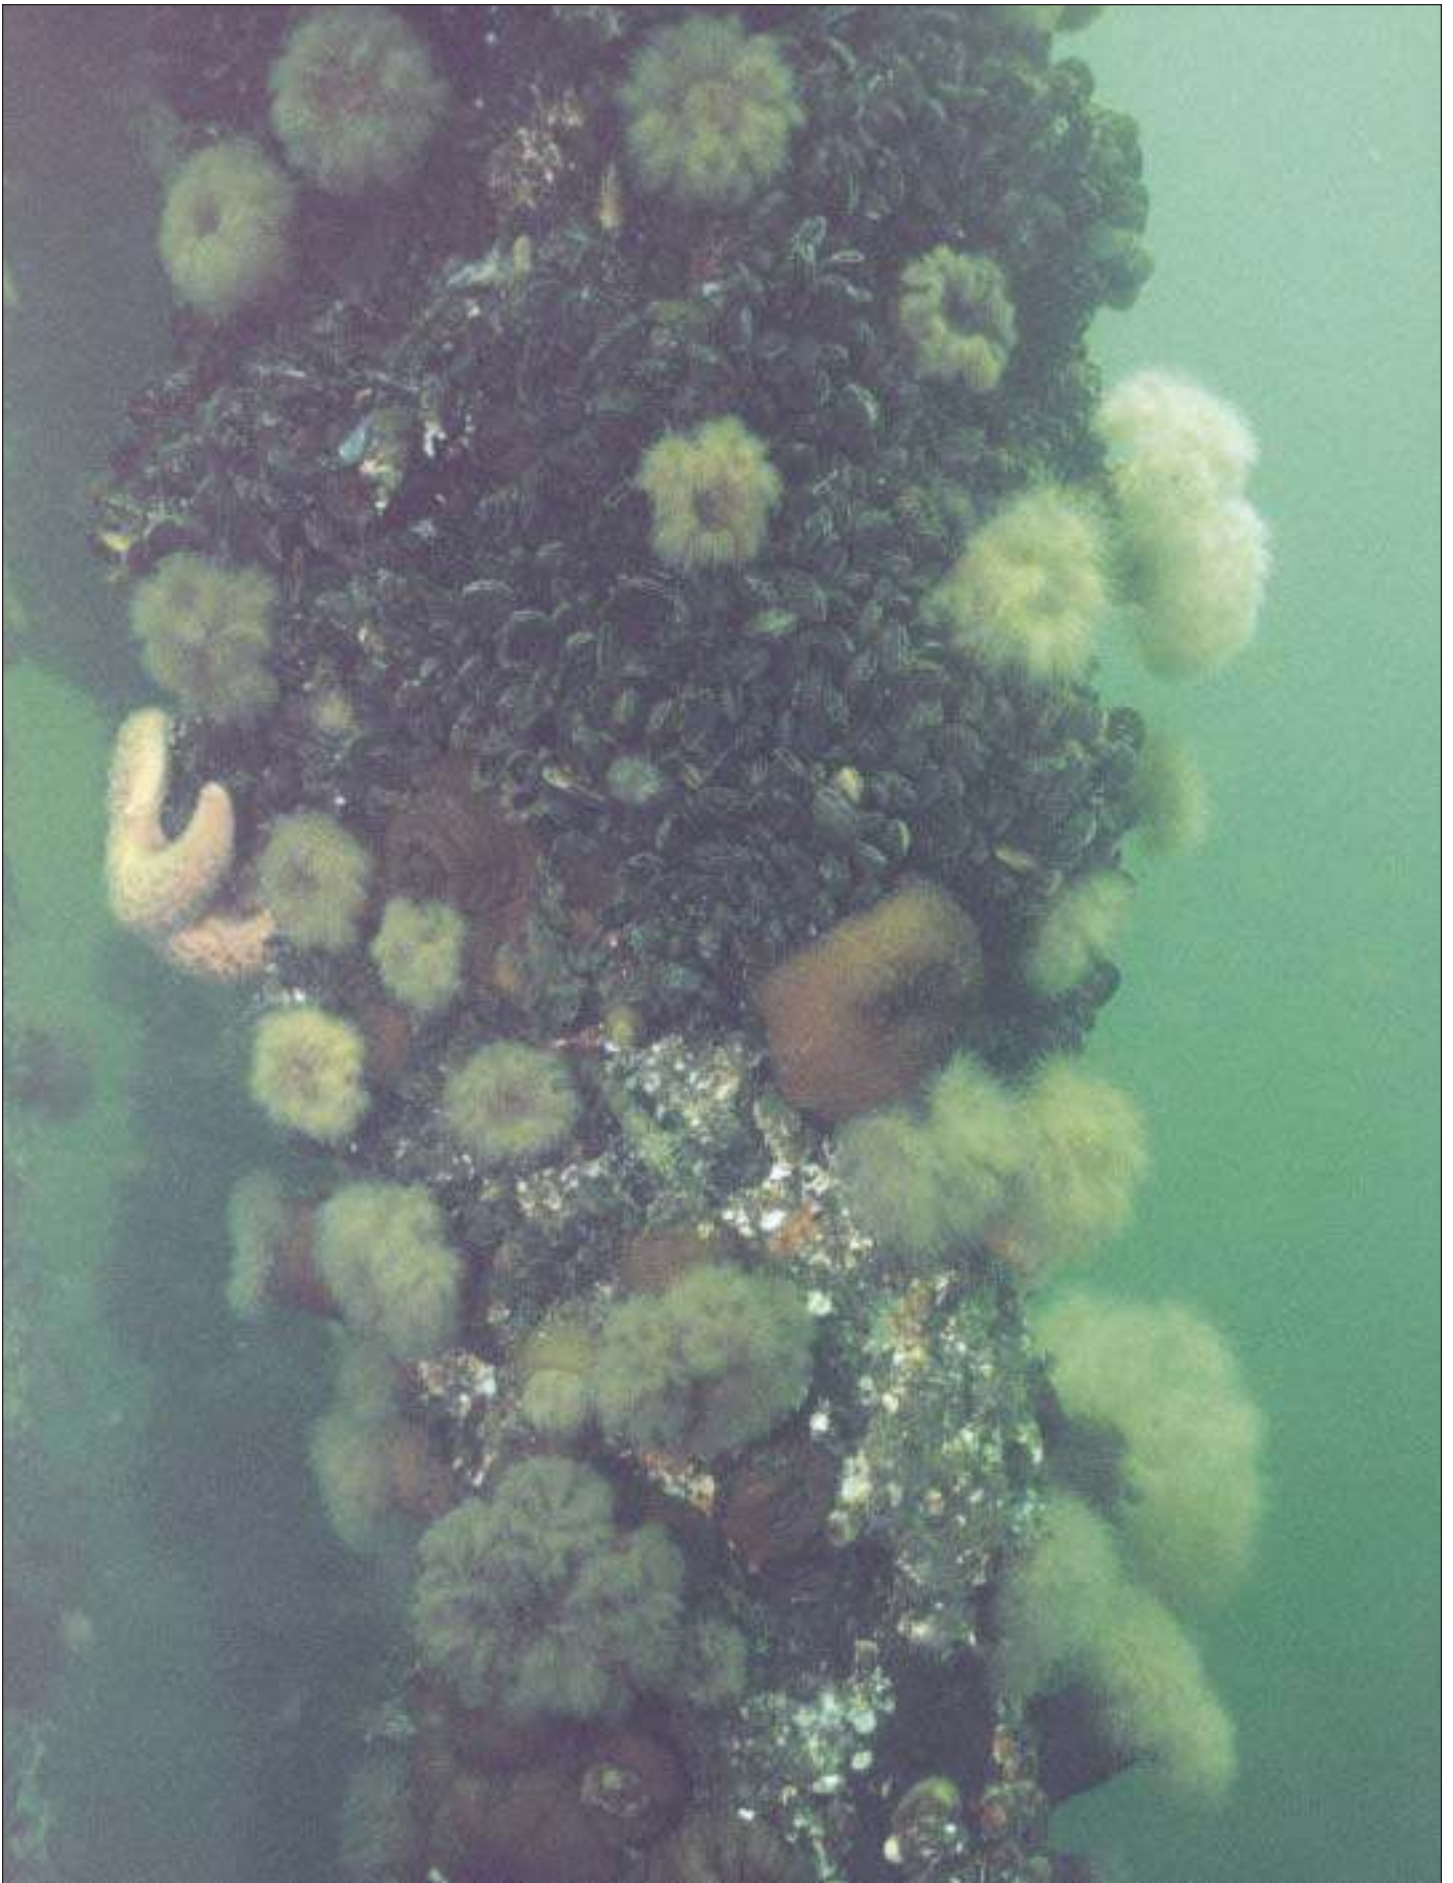
- The continually immersed portions of the creosote-treated piling were quickly overgrown with a rich and abundant community of fouling organisms. The full-page photograph on the next page shows one of the newly treated creosote piling at the end of the study. Dozens of species were identified including fish, shrimp, nudibranchs and tunicates such as *Cnemidocarpa finmarkiensis* shown at left. From an intuitive point of view, this luxuriant fouling community does not suggest that these piling were creating a toxic environment.

*Invertebrate community growing on a new creosote-treated marine piling in Sooke Basin*

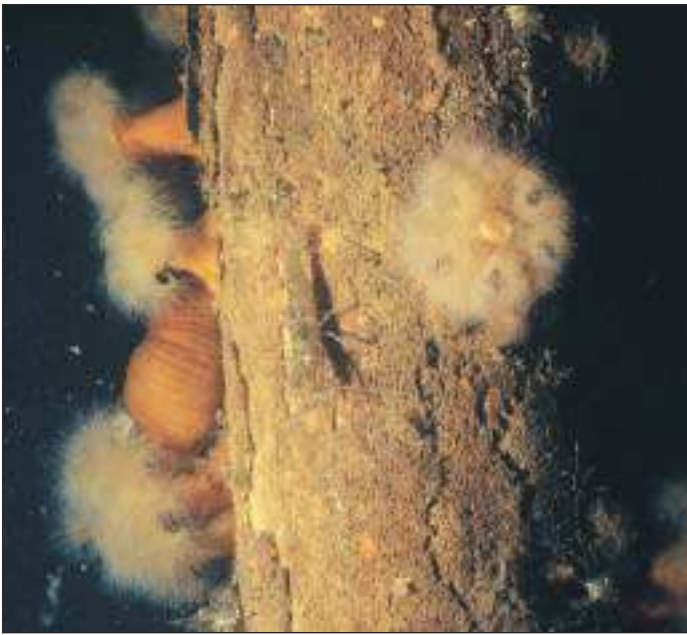
*The untreated piling were deteriorating and did not support a vibrant fouling community*

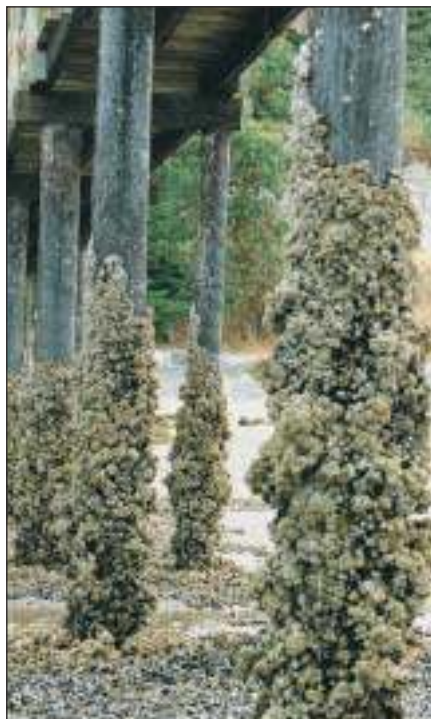
*The personal use pier shown here is constructed of creosote-treated piling with ACZA-treated walkways*

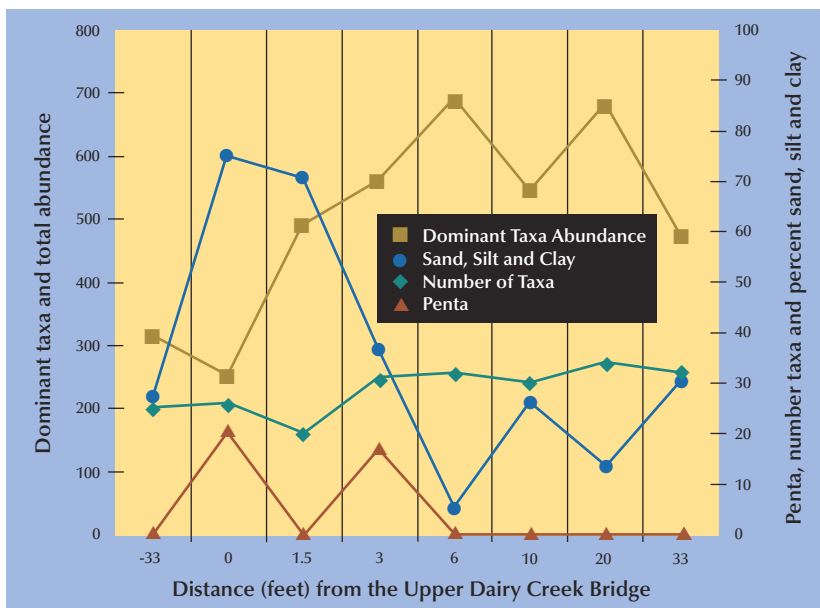
Figure 5

These two bridges were located over salmon-spawning rivers with sand-gravel and cobble substrates supporting a vibrant community of pollution-intolerant aquatic insects in the Orders Ephemeroptera (mayflies) and Trichoptera (caddis flies). The larvae of these Orders are generally associated with fast-moving oligotrophic streams and rivers. The biological response of this sensitive community is illustrated in the figure below. It describes sediment pentachlorophenol concentrations ( $\mu\text{g}/\text{kg}$ ) in red; the proportion fine-grained sediments (sand, silt and clay) in blue; biological response described by the number of species (green); and the abundance of invertebrates (brown).

Note that the number of species and the total abundance of invertebrates were much higher three feet downstream from the bridge's drip line where the proportion of fine sediments dropped from 70 to 80 percent to about 40 percent. Also note that invertebrate abundance peaked where the proportion of fines decreased to between five and 12 percent. There were as many species and as many animals downstream from the bridge as there were at the upstream control. And there was essentially no correspondence between invertebrate community and the small amount of pentachlorophenol observed under the bridge and at the station located three feet downstream. Amphipod (*Hyaella azteca*) bioassays also found no evidence of toxicity in sediments from either of these pentachlorophenol-treated bridges. The invertebrate community was far more influenced by the substrate type than by the bridge.

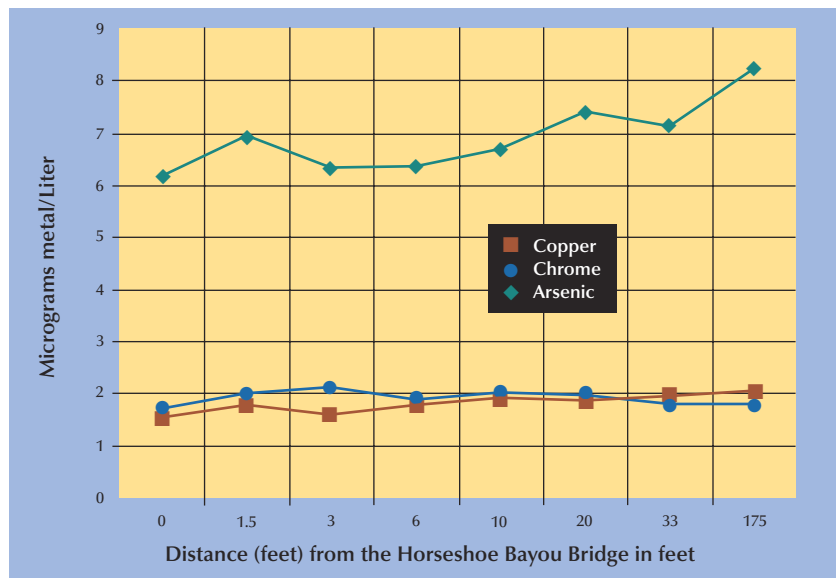
Figure 6

It should be noted that all metals were below their respective water quality criteria of 3.1  $\mu\text{g}$  copper/L, 36  $\mu\text{g}$  arsenic/L and 50  $\mu\text{g}$  chromium (VI)/L. As shown in Figure 7, increased sediment concentrations of all three metals were observed within 10 feet of the bridge.

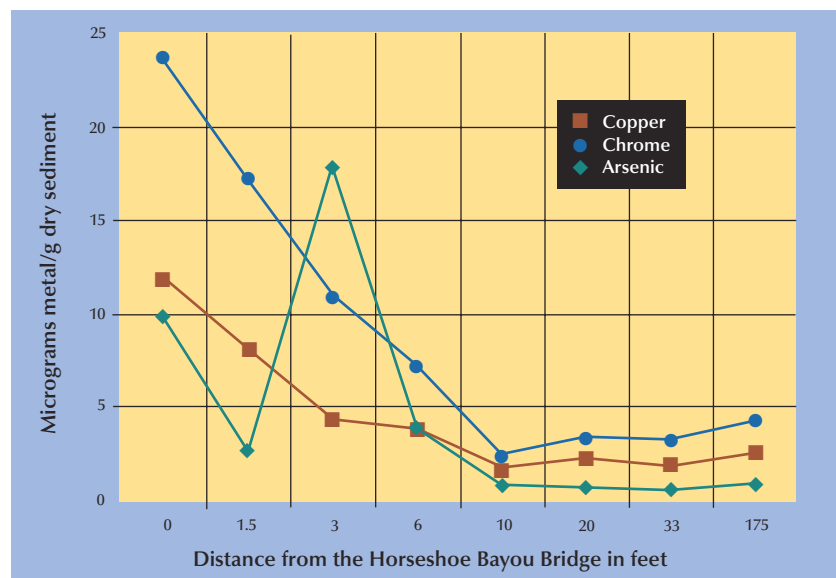
Figure 7

The reason for the increase illustrates an important point in the construction of treated-wood structures. As previously noted, this is a truly massive bridge. One thousand four hundred fifty-eight holes were drilled in the bridge to bolt together the heavy-duty treated-wood railing. Each hole was 3/4" in diameter and approximately 14" long. The drill shavings were not contained and they blew into the estuary where they could be seen on the bottom all around the bridge.

There are at least two reasons why the drill shavings, although an esthetic problem, did not result in measurable environmental damage. First, because the metals remained fixed in the wood shavings, they were expected to slowly leach out over time. Second, the resulting concentrations did not exceed commonly accepted sediment benchmarks of 63.4 µg copper/g; 16.2 µg chromium/g; or 24.4 µg arsenic/g dry sediment. This poor housekeeping practice resulted in what should be recognized as unnecessary environmental risk. There is no reason for those shavings to be there.

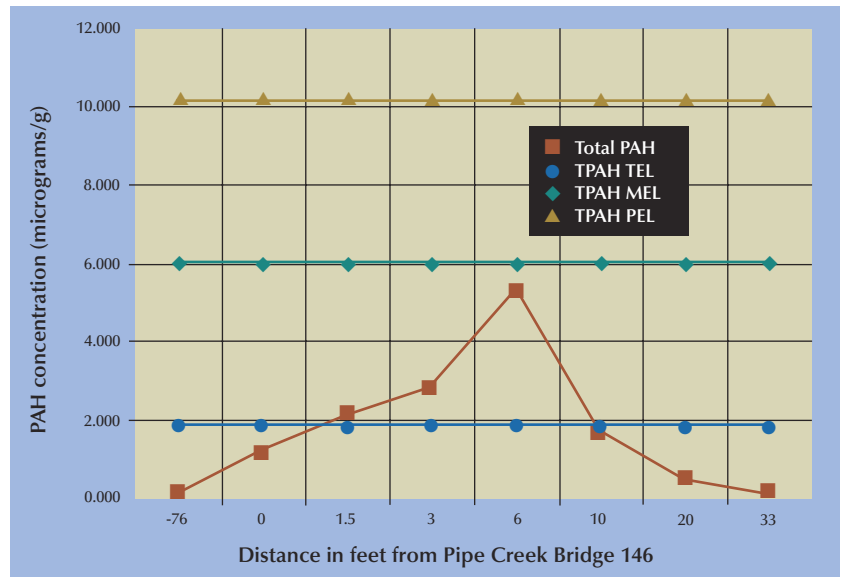
Figure 10

Sediment concentrations of polycyclic aromatic hydrocarbons (PAH) are described in Figure 10. This graph also includes sediment quality benchmarks described as the Threshold Effects Level (TEL), a value below which adverse biological effects are not generally observed under any condition, and the Probable Effects Level (PEL), a value above which increasingly severe biological effects should be anticipated in most environments. The mean of these values or MEL is also displayed. This mean is increasingly used as a reasonably protective benchmark for assessing environmental risk. Maximum sediment PAH concentrations between 1.5' and 6.0' downstream from the bridge exceeded the Threshold Effects Level for TPAH but not the Mean Effects Level. This suggests that adverse effects could be anticipated in a community of the most sensitive organisms.

As previously discussed, Pipe Creek is a slow-moving stream flowing through cropland. It carried a significant bedload of sand, silt and clay. Like the Wildwood wetland, this is a naturally stressful environment and the invertebrate community was dominated by annelids (worms) and chironomids (midges). Both groups are generally robust and typically dominate other taxa in stressful environments. Therefore, it could be anticipated that the moderate levels of PAH observed in these sediments would not adversely affect this robust resident invertebrate community – and they did not.

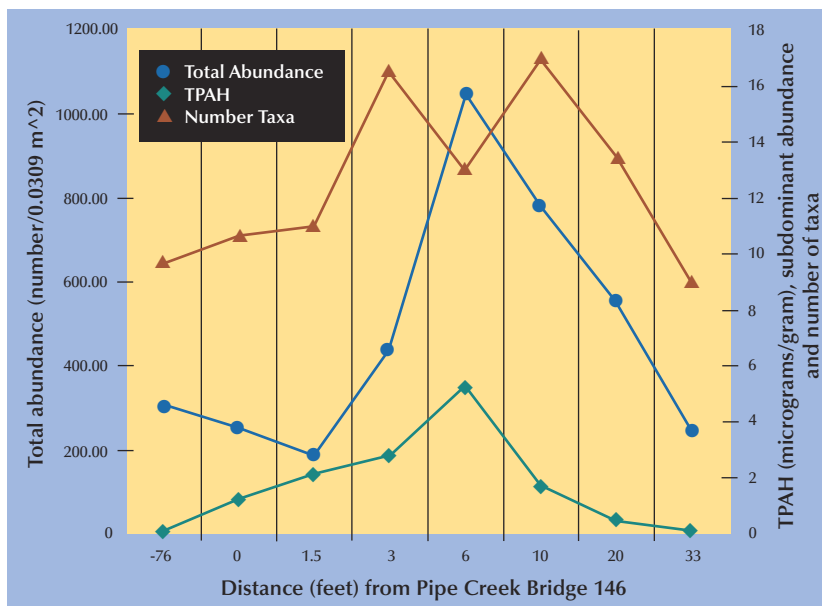
Figure 11

The point that should be made is that neither of these bridges lost enough PAH to affect the creek's invertebrate community. The results of this study were also consistent with those obtained in Sooke Basin. Lower sediment TPAH concentrations were observed at the older bridge and higher concentrations at the new bridge. Experience has shown that creosote- and pentachlorophenol-treated bridges are most likely to lose preservative during the first year following construction – particularly during extended periods of high ambient temperatures. Oil-type preservative losses decline significantly with time.
